Evaluation of Installation Damage of Geotextiles. A Correlation to Index Tests

R. Diederich

DuPont de Nemours Luxembourg S.A.

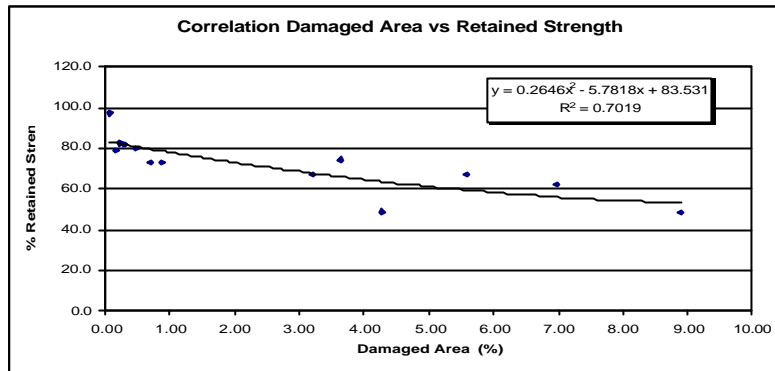
The correlation of the total damaged surface area (%) with all of the index tests has been compared. A good correlation has been observed between the damaged surface area and retained strength.

Figure 3: Correlation between damaged area and retained strength

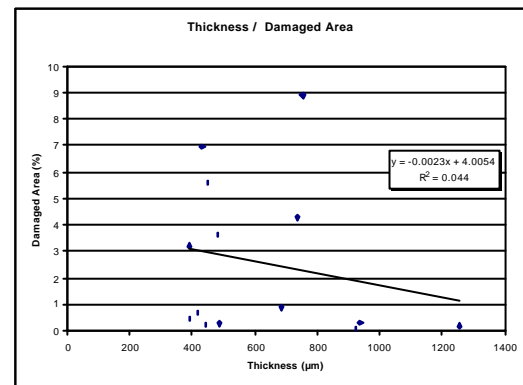
Unit weight and thickness are descriptive properties only and do not provide any information relating performance when comparing different products. Only for products of the same “family” (i.e. manufactured according to the same process), is the damage resistance directly related to the uniform spread of its unit weight. At a uniform external stress, it is the weakest parts of the geotextile, which are the first to be damaged. For specification purposes, average unit weight and thickness are however irrelevant, since the unit weight to achieve a given performance depends on the different manufacturing technique.

fig:5 Correlation with Thickness

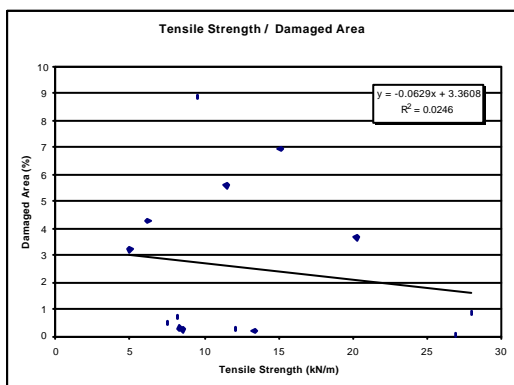
No correlations were identified between the damage and any of the mechanical properties such as tensile strength, CBR puncture resistance, grab tensile strength and tear resistance.

fig:6 Correlation with Tensile Strength

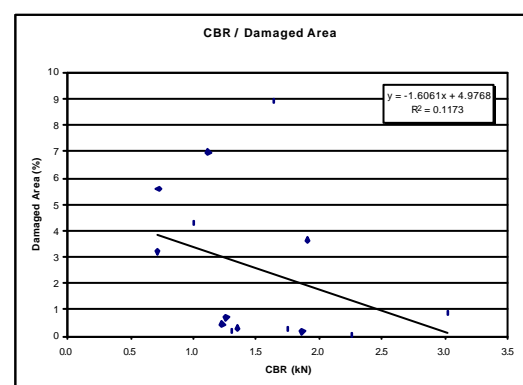
fig:7 Correlation with Puncture Strength

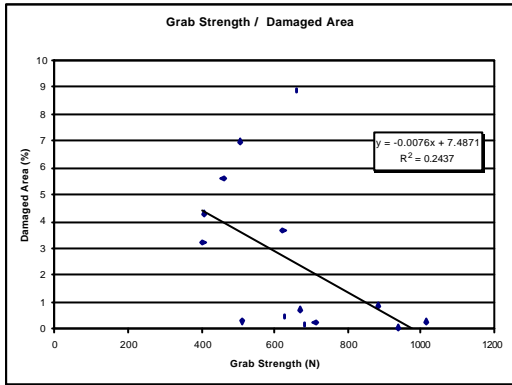
fig :8 Correlation with Grab Strength

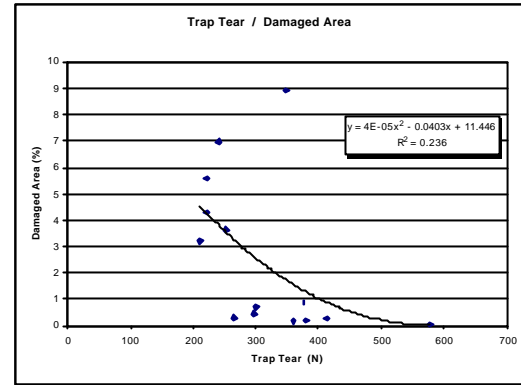
fig :9 Correlation with Tear Strength

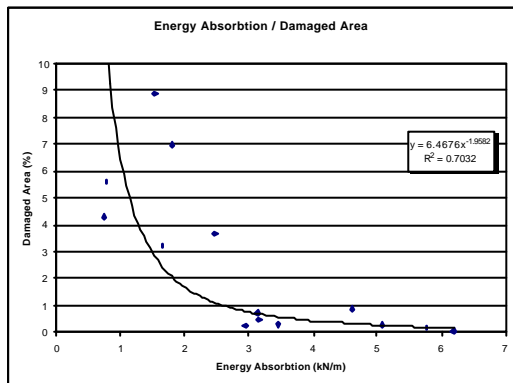
Excellent correlation has been found between the damaged area and the energy absorption (defined as the area under the stress-strain curve determined according to EN ISO 10319). Under the used test conditions it is clearly seen that all geotextiles with an energy absorption of less than 3 kN/m have showed significant damage, whereas those geotextiles with an energy absorption greater than 3 kN/m survived these conditions without major damage.

fig : 10 Correlation with Energy absorption

A clear correlation between energy absorption and damage resistance has been found for all geotextiles tested, independent of their manufacturing process and physical structure. A common criteria based on the energy absorption principle allows the specifier to select the appropriate product performance depending on the different applications and site conditions. The test method developed allows a rapid and precise damage evaluation of geosynthetics and may be used as a basis for further determining performance related criteria.

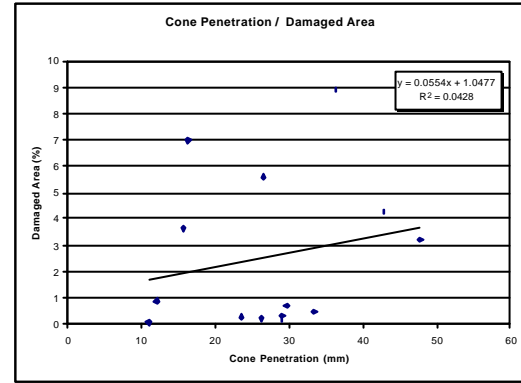
Although dynamic puncturing (Cone Penetration) is usually seen as a performance test simulating real conditions, little correlation has been observed during this test. As the dropping height in the trial was however limited to 50 cm, the cone penetration test may have a higher significance as the aggregate dropping height increases.

fig : 11 Correlation with Cone Penetration

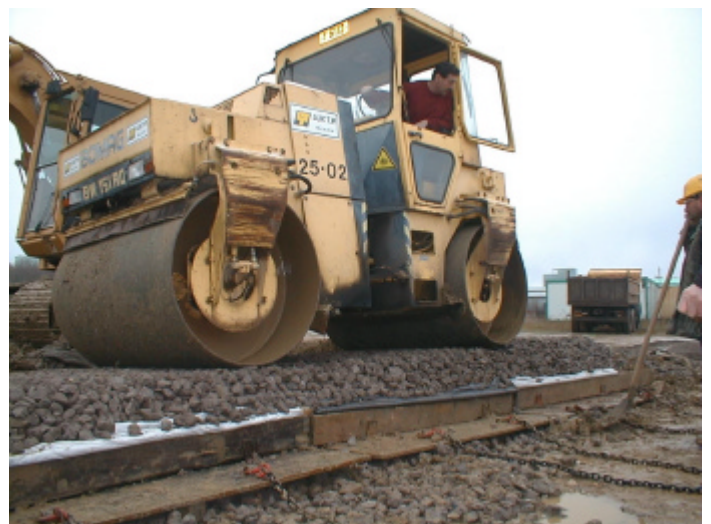
Steel plates (2 x 2.50 m) with steel chains at the edges were constructed. Compacted soft clay subgrade from the local site was placed on top of the plates at a height of 25 cm. A 2 x 2 m geotextile sample was laid directly on the subgrade and covered with a 25 cm high layer of high furnace slag (40-60cm diameter) dropped from a height of 50 cm. The system was compacted with a 7-tonne vibratory roller with 4 passes (forward and backward).

Compaction (4 passes)
